Manhole Inspection Summary

Manhole # S43OO_036MH

Insp Date: **4/2/07 11:45 AM**

Location Address: **2120 HARFORD RD**

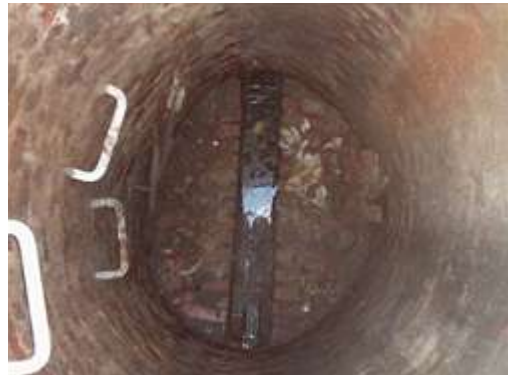
Top View

Corbel infiltration. Corroded steps.
Evidence of surcharge - Bench debris.
Channel debris.

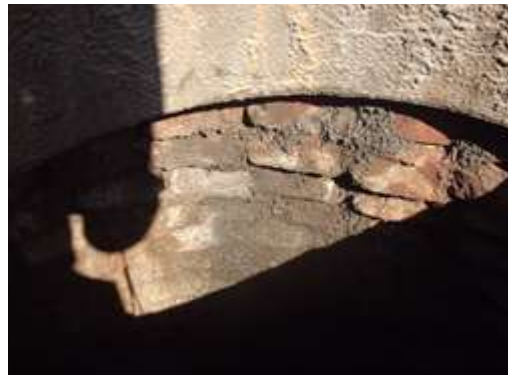
Defect

Frame leaks. Adjustment deterioration
and infiltration. Corbel infiltration.

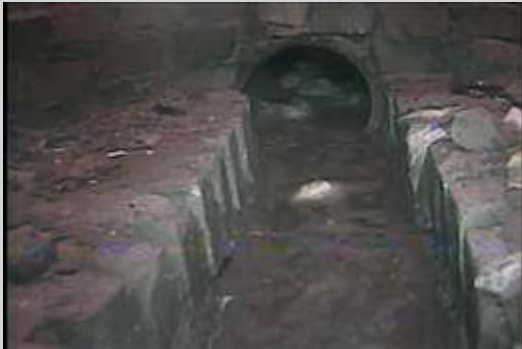
8 in. Circular Gravity Sewer Pipe Out @ 12 O'Clock

Deposits: ☐ None ☒ **Mud** ☐ Sludge ☒ **Debris** ☐ Grease

Silt Depth: **2** (in.) Deposits Extent: **Light**

Infiltration: **Evidence** Pipe Seal Cond: **Unknown**

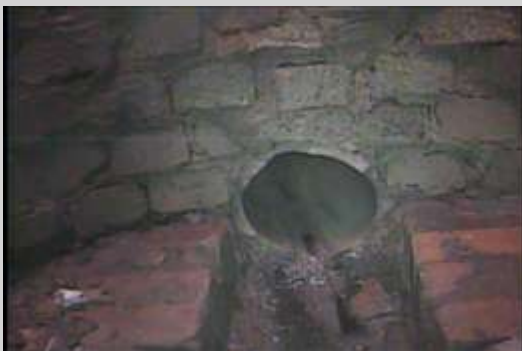
6 in. Circular Gravity Sewer Pipe In @ 6 O'Clock

Pipe Seal Cond: **Broken**
